# Manhole Inspection Summary

Manhole # S17GG2017MH

Insp Date: **10/23/06 4:18 PM**

**Location** Address: **5706 SMITH AVE**

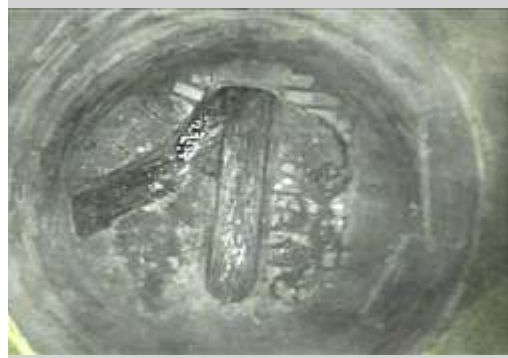
Top View

☒ **Debris** (not Condition related)

☒ **Corroded**

☒ **Evidence Of Surcharge**

Corroded steps. Evidence of surcharge - Bench debris.

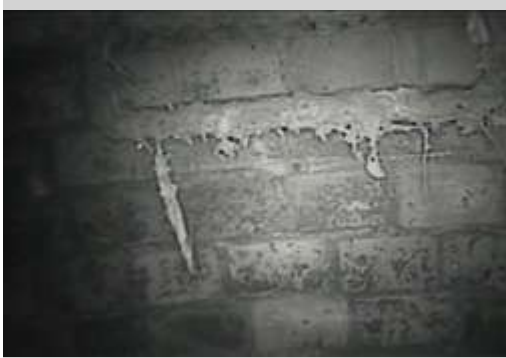
Defect

Depth: **1.5** (ft.)

Evidence of surcharge.

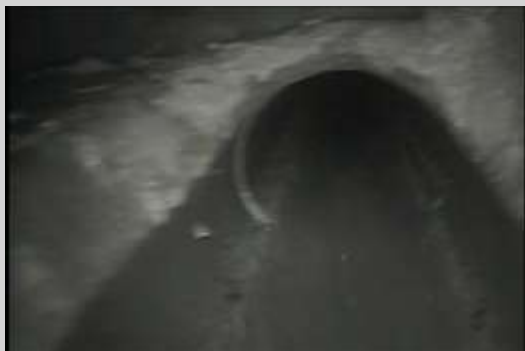
### 10 in. Circular Gravity Sewer Pipe In @ 6 O'Clock

Infiltration: **Evidence** Pipe Seal Cond: **Unknown**
